Annual Inspection Report

Village Play Area

Client:	Nether Wallop Parish Cpouncil
Address:	F.A.O. Gail Foster Kingsmans Cottage Nether Wallop Stockbridge Hampshire SO20 8EW
Date:	7th May 2020
Inspector:	Peter Briggs

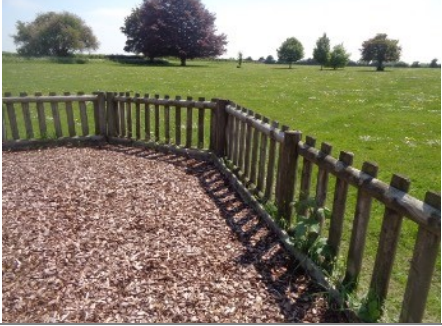
Item	Fencing				
Supplier	Unknown				
Surface	N/a				
Risk Rating Overall	Very Low	Low	Medium	High	Unacceptable
			8

Rot/decay evident throughout. Recommendation: Consider to replace as required.	8

As above finding. Recommendation: As above comment.	8
	Recommendation:	
	Recommendation:

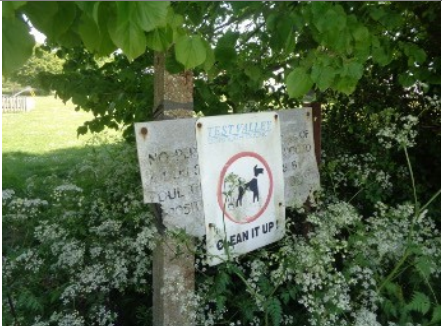
Item	Signage				
Supplier	Unknown				
Surface	N/a				
Risk Rating Overall	Very Low	Low	Medium	High	Unacceptable
		5

Signage poor - damaged. Recommendation: Consider new signage.	5
	Recommendation:	
	Recommendation:	
	Recommendation:

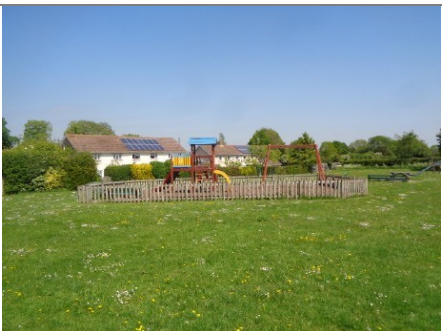
Item	Site				
Supplier	Unknown				
Surface	N/a				
Risk Rating Overall	Very Low	Low	Medium	High	Unacceptable

Site closed due to Covid-19
Recommendation:
Monitor use.

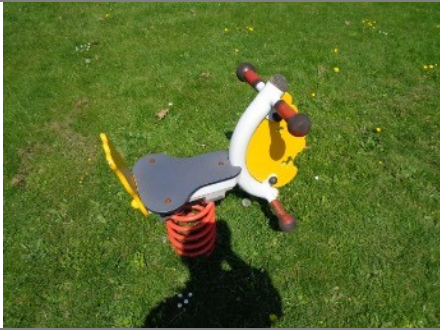
Item	Spring Unit				
Supplier	Sutcliffe				
Surface	Grass				
Risk Rating Overall	Very Low	Low	Medium	High	Unacceptable
		4

Grass surfacing at present.

Recommendation:
Consider safety grass matting for this item.

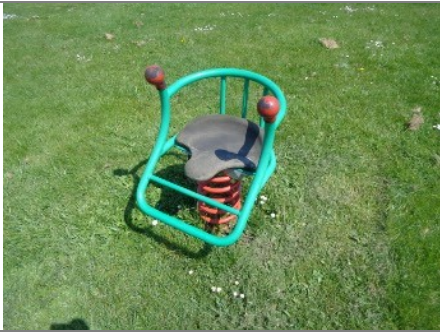
Item	Spring Chair				
Supplier	Sutcliffe				
Surface	Grass				
Risk Rating Overall	Very Low	Low	Medium	High	Unacceptable
		4

Grass surfacing at present.

Recommendation:
Consider safety grass matting for this item.

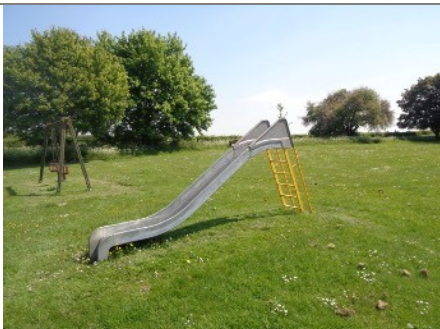
Item	Slide				
Supplier	Unknown				
Surface	Grass/Grass Matting				
Risk Rating Overall	Very Low	Low	Medium	High	Unacceptable
		7

Slight dents in chute area.

Unsure if grass matting extends around slide perimeter.

Recommendation:
Monitor this condition.

Recommendation:
Review and consider if necessary to install grass matting all round unit.

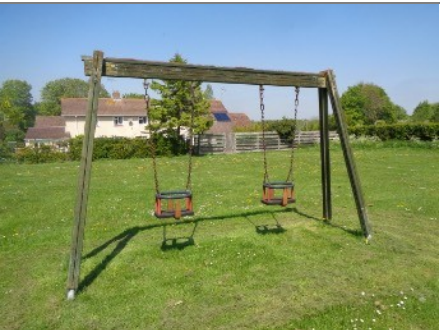
Item	1 Bay 2 Cradle Swing - Limited Life Unit.				
Supplier	Lappset				
Surface	Grass				
Risk Rating Overall	Very Low	Low	Medium	High	Unacceptable
			12

Chain wear evident. Recommendation: Monitor and replace at 40% diameter of wear.	7

Grass surfacing at present. Recommendation: Consider safety grass matting for this item.	7

Loose fixing to cross bar. Recommendation: Retighten as required. Review "D" shackle and bush for evidence of wear as well.	12

Wooden items show evident of weathering and decay in places. Recommendation: Monitor to review condition of the wood.	10
